**Cyclox  
Cycle Parking  
& Abandoned Bikes**

**Winter 2008/09**

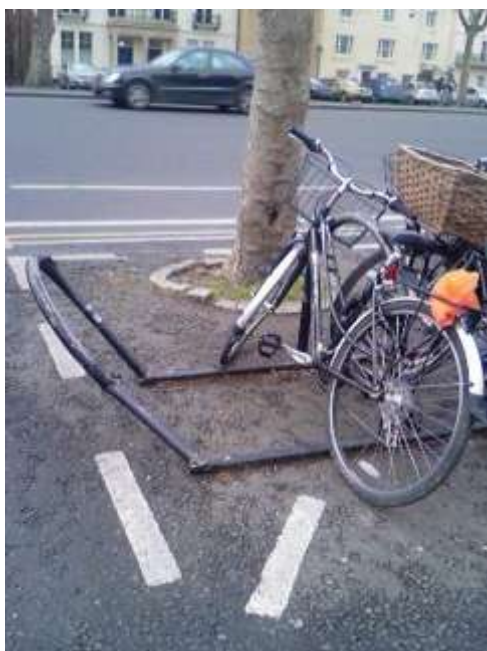
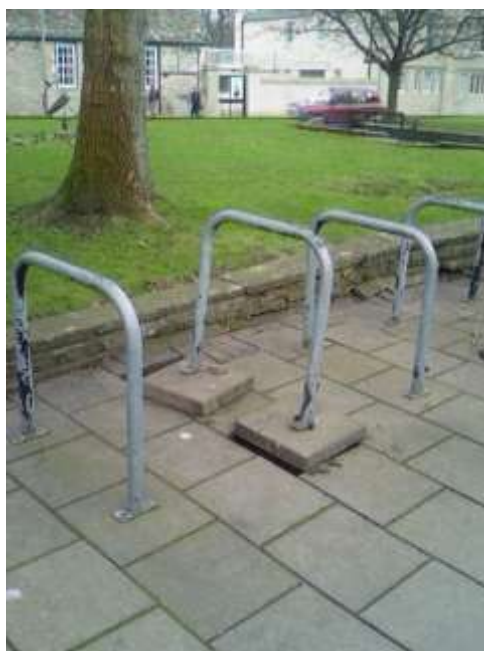
### 6.1 Damaged and unusable stands

Broken cycle Sheffield stands (toast rack) account for a small number of all places. However Sheffield stands are usually too narrow for easy use, and those with horizontal ground bars make it difficult for a bike to be well positioned, so the bikes tend to fall and then protrude into the road or fall onto the pavement. On the other hand many butterfly (wheelbender) parking places become unusable because the fixing bolts get loose. They also offer inferior security and risk damage to the front wheel.

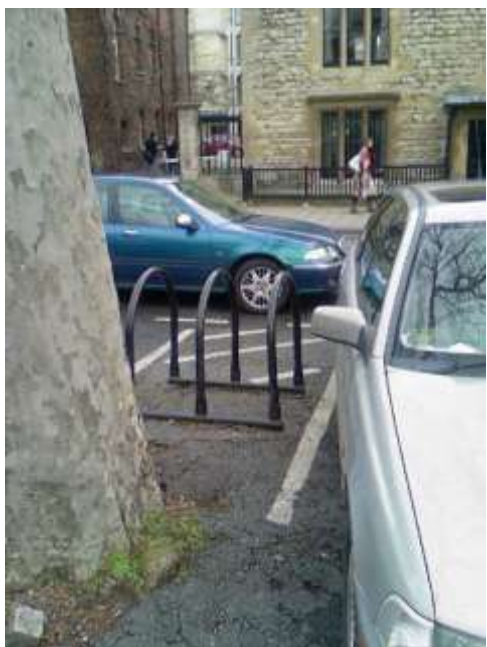
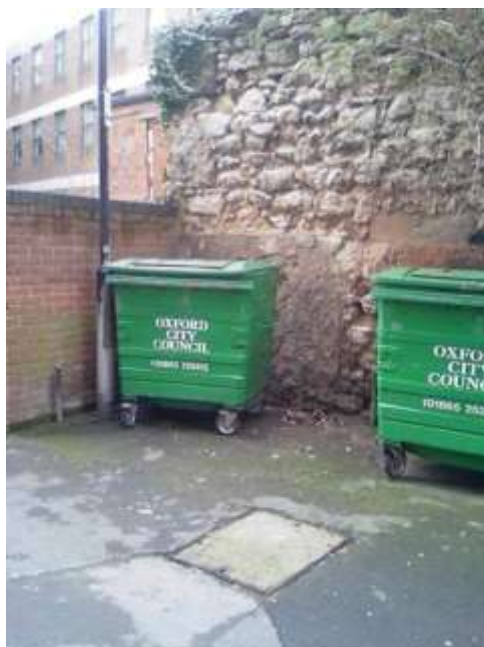
Some Sheffield racks are so badly positioned they cannot be used whereas other parking places get used for waste bins.

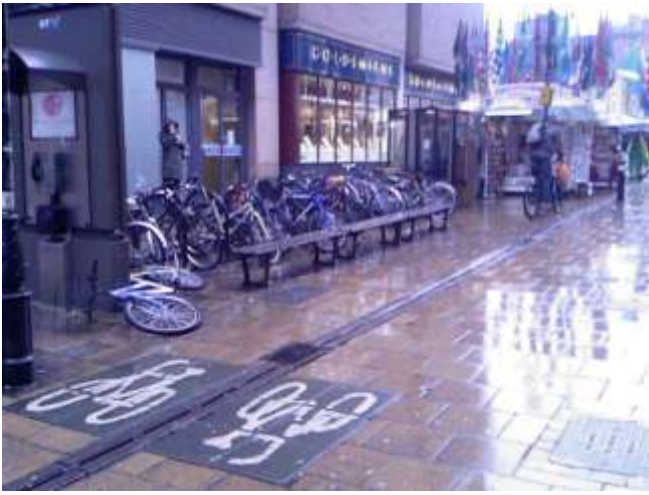
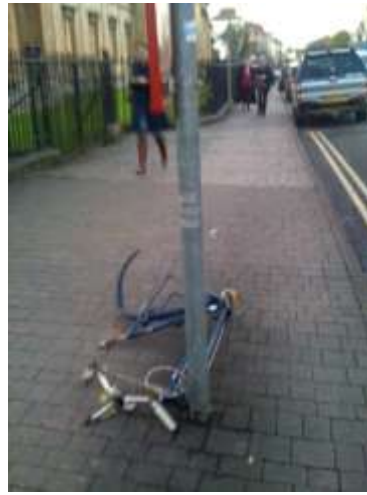
## 6.2 Abandoned bikes

There are four sites where the number of abandoned cycles is considerable – arguably, unacceptable. It would appear that whoever is clearing abandoned cycles is not working from a comprehensive list of sites and the locations in table 5.2 need to be reviewed more frequently.
